Statewide Survey of Historic Properties

Site Number: 326-0425

Survey Report for McClellanville

Historic Name: Sarah Butler Doar House

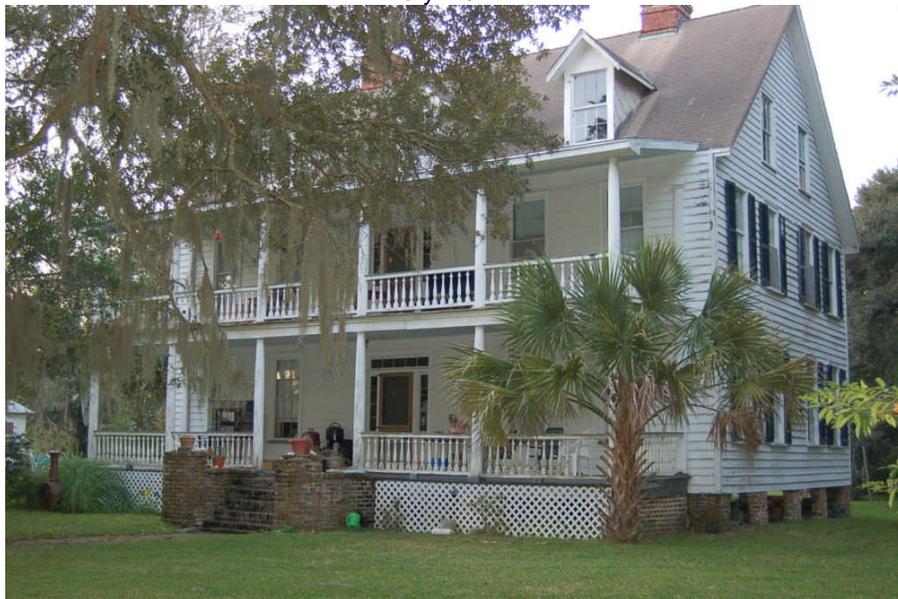
Primary View:

Significant Architectural Features: two interior brick chimneys; two-story porch on south facade; 6/6 windows; three gabled dormers with 6/6 windows on north and south facades. First level entrance has transom and sidelights. Second level entrance has sidelights. Asbestos shingles at rear section. One-story rear gable kitchen wing attached by breezeway.
