# Statewide Survey of Historic Properties

## Survey Report for McClellanville

Site Number: 326-0427.00

Historic Name: Louis Augustus Whilden House  
Common Name: Doar Cottage  
Address/Location: 125 Oak Street (127 Oak per Chas Co.)

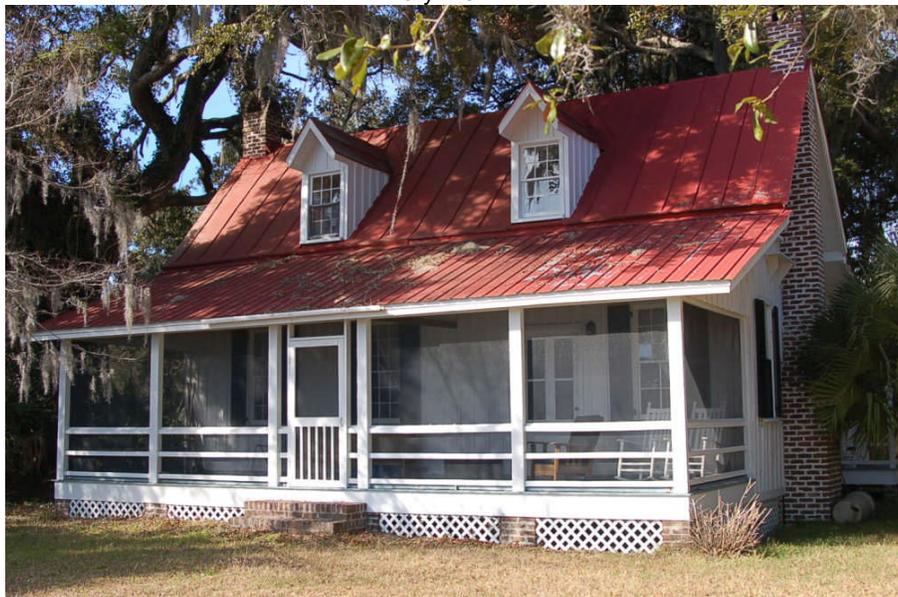
Primary View:

Significant Architectural Features: board and batten siding; 2 gabled dormers on north and south slopes with 6/6 windows and wide eaves; 2 exterior brick chimneys (east and west gable ends) with gothic caps; shed roof over side entry--east; 9/9 windows on first floor south elevation. Off-center four panel entry door.

Alterations: entry door altered--upper two panels removed and replaced with glass. Two single-story rear shed additions--last one c. 1950. Replacement foundation (1990); chimneys repointed/rebuilt after Hugo.
