Statewide Survey of Historic Properties

Survey Report for McClellanville

Site Number: 326-0462

Address/Location: 710 Morrison Street

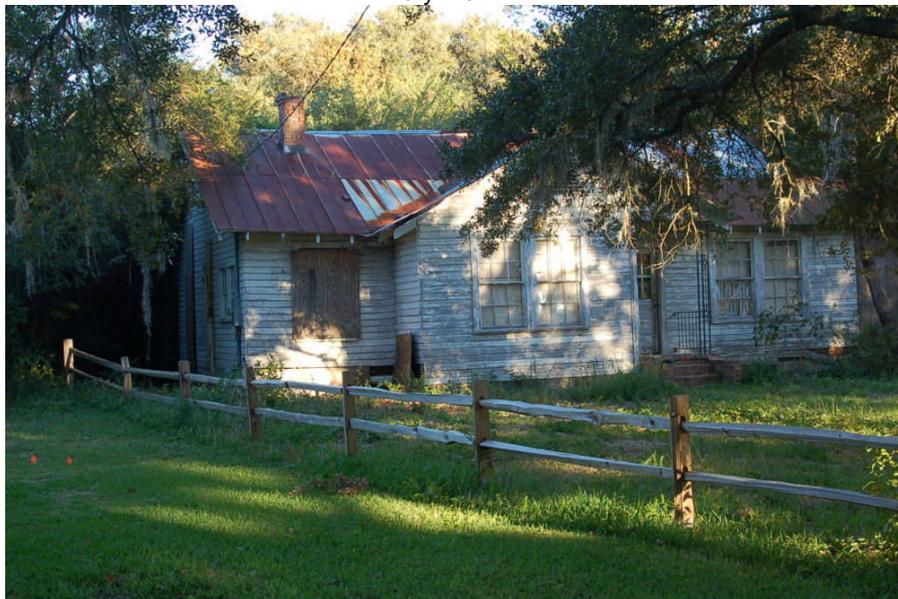
Primary View:

Significant Architectural Features: front gable projecting bay at west façade with porch engaged at its south bay. Lateral gable extension at first bay, south elevation. Exposed rafter ends; 6/6 windows; louvered vent in gable end.

Alterations: modern metal post on porch. Plywood over porch and brick pier filled with cement blocks (post 1992 survey).
